Aeronautical Engineering

SR-71 Imposes Burden On Maintenance Units

Beale AFB, Calif.—Extreme operating environment and the unique structure, propulsion and subsystems of the U. S. Air Force/Lockheed SR-71 strategic reconnaissance aircraft impose a heavy maintenance burden on the units responsible for keeping SR-71s flying.

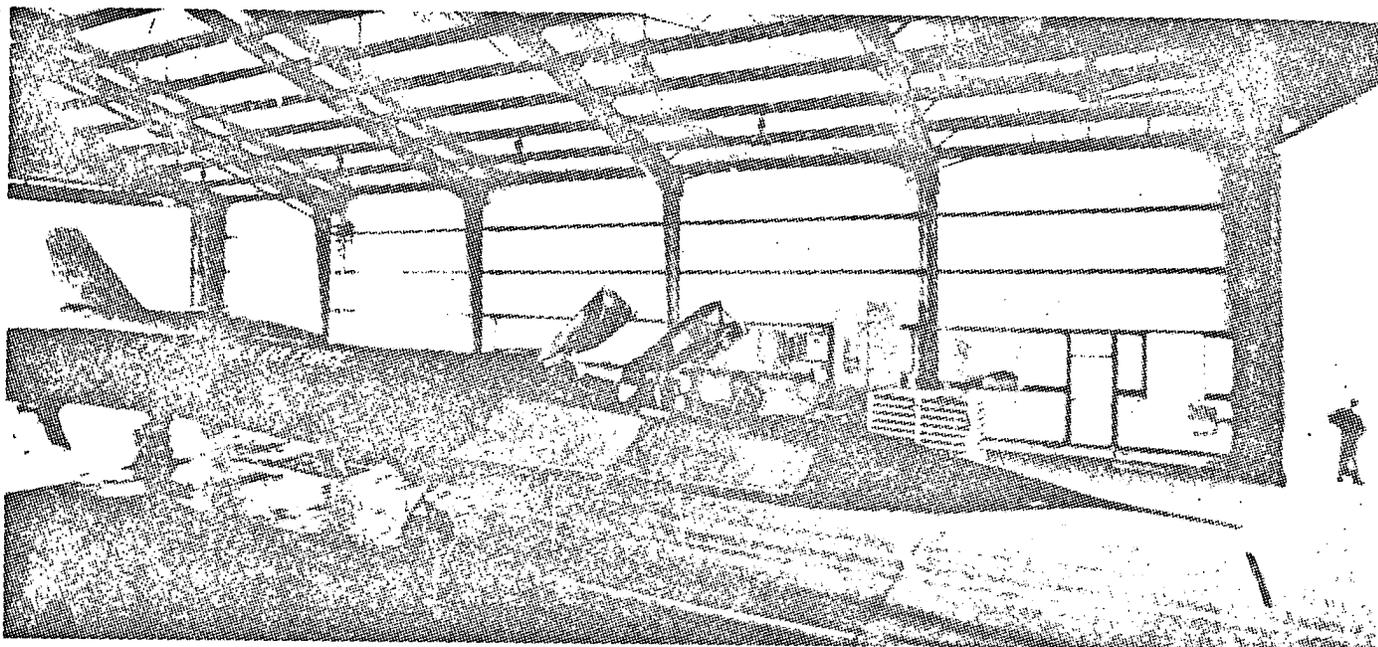
Post-flight inspection of the Air Force/Lockheed SR-71 contains 650 items. It takes five specialists about 6 hr. to inspect the aircraft.
